7. CONSERVATION PROCESS

Gilberto Zorio

Los Zorios

Leather wineskin, aniline, vaseline, lanolin, alcohol, steel, copper, glass crucible, copper sulphate in water, compressors, halogen lamp; installation with movement and sound.

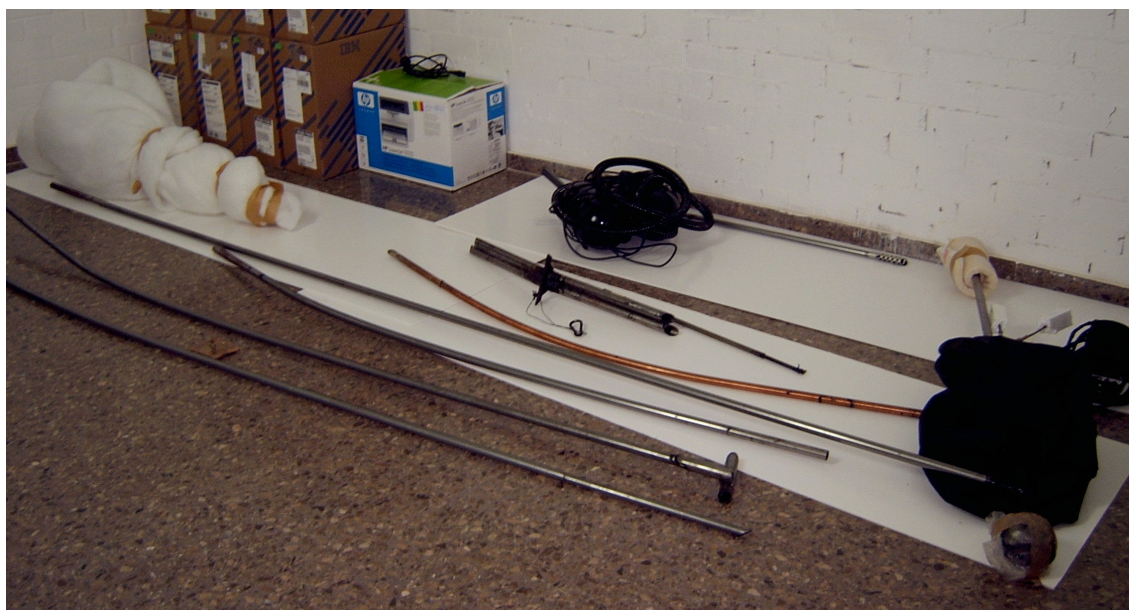
Initial state of the piece on arrival at the Restoration Department and unpacked.

In general, the work is in a poor state of conservation, because of unsuitable storage and packaging between 1997 and 2006, when it arrived at the IVAM storerooms.

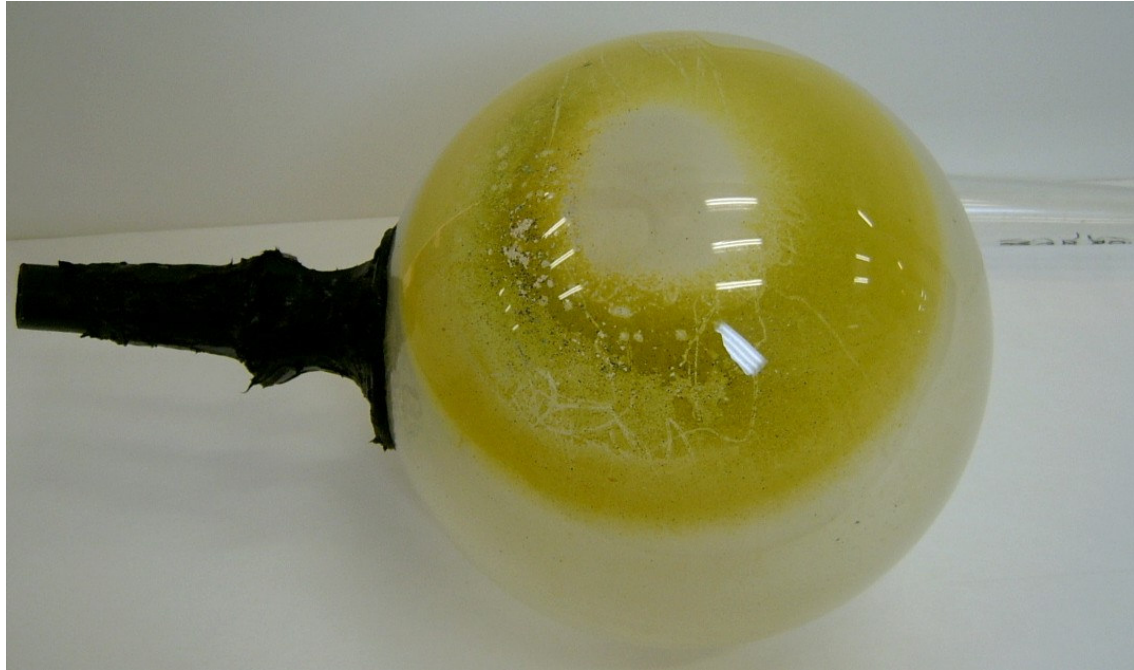
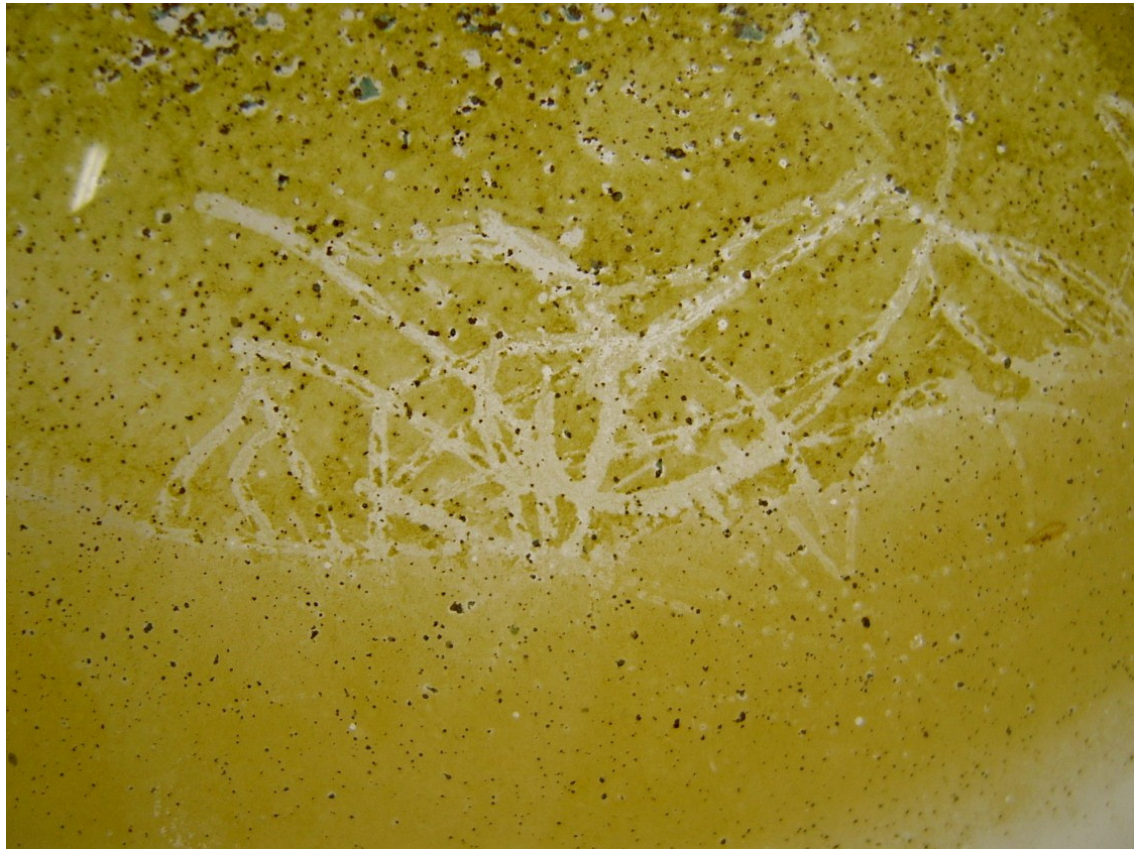
Large crusts of copper sulphate, concretions, stains and dirt on the inside of the crucible. However, it is not scratched or cracked.

The copper sulphate is completely crystallised.

Traces of copper sulphate.

Hot vinegar is applied to the crucible for seventy-two hours running to clean it. The marks that were still left were removed with water and rice to exert a little friction. In this way, all the concretions were removed with the exception of some tiny stains at the top of the axis. The inscription of the title was removed at the artist's request.

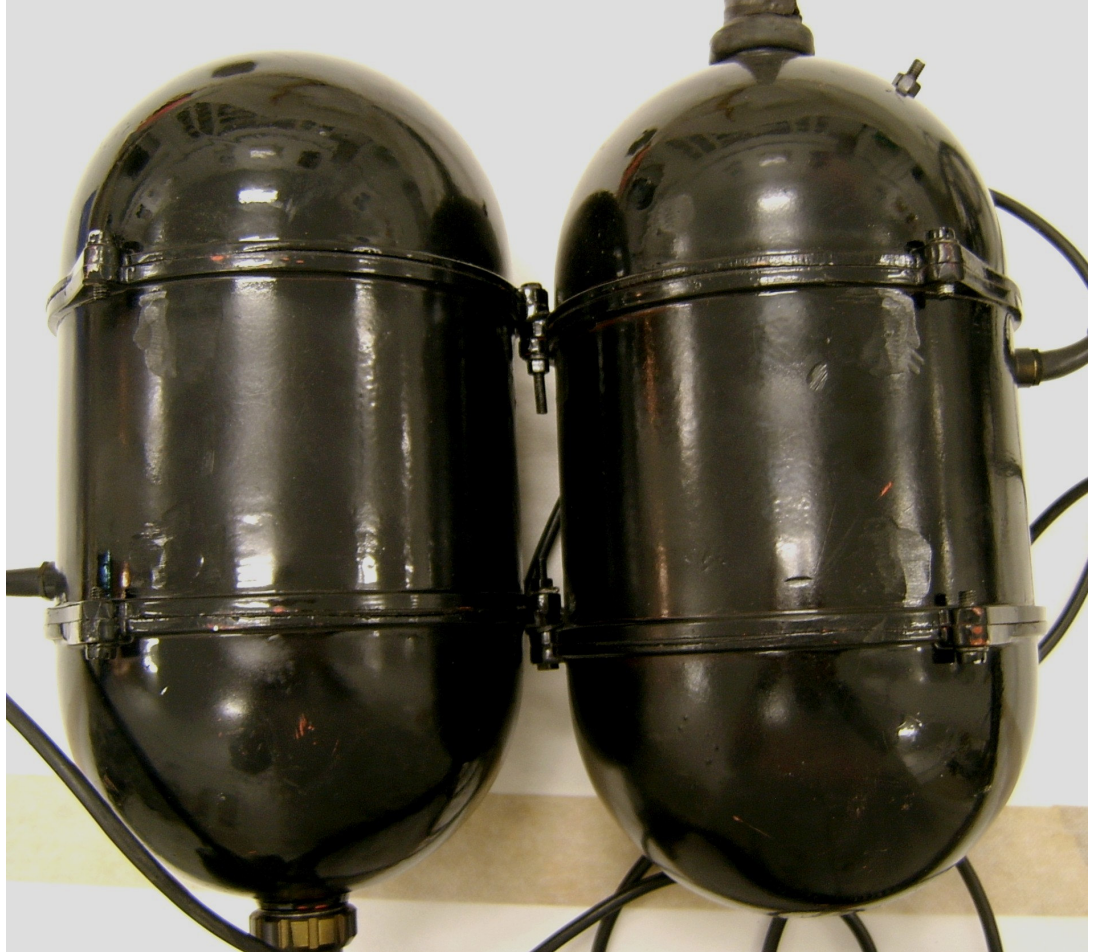
The compressor is dented and scratched and some of the black coating is missing. The black coating is missing in some places because the artist failed to apply it. Black paint is missing from the compressor's plastic tube. The black rubber at the end of the tube has been cracked by stress. The metal tube is slightly rusted. Nevertheless, the compressor is in perfect working order.

Scratches and bald patches in the paint on the compressor.

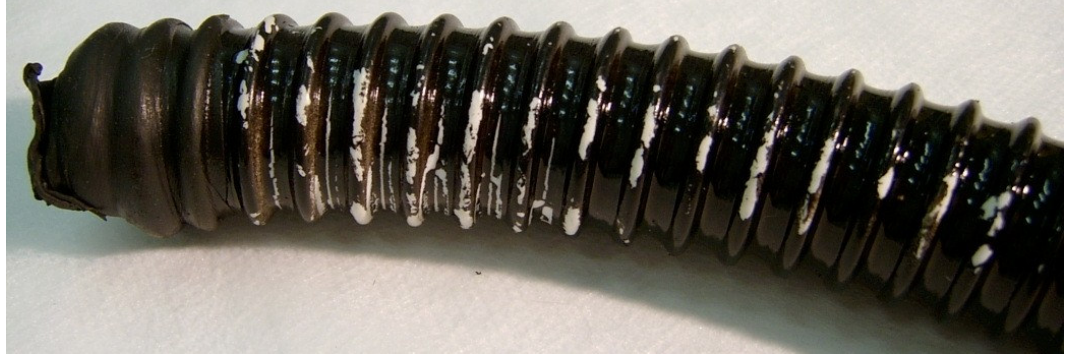
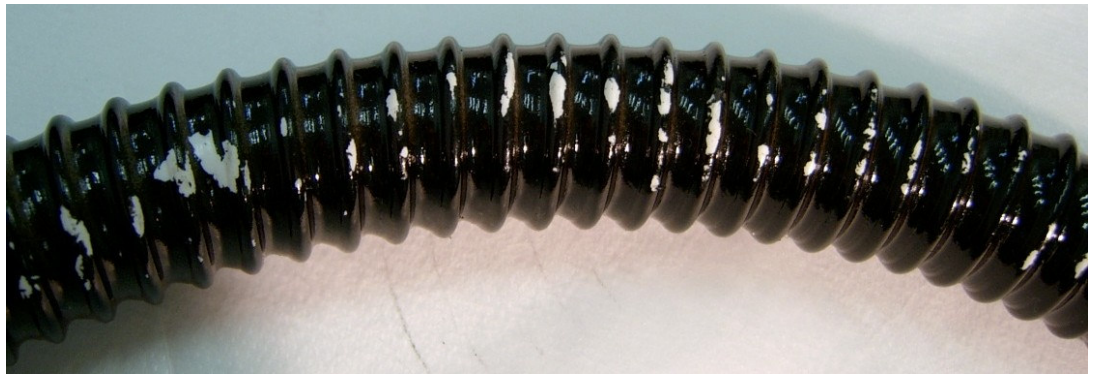
Loss of black coating on the tube of the compressor.

The compressor tube is repainted black at the artist's request.

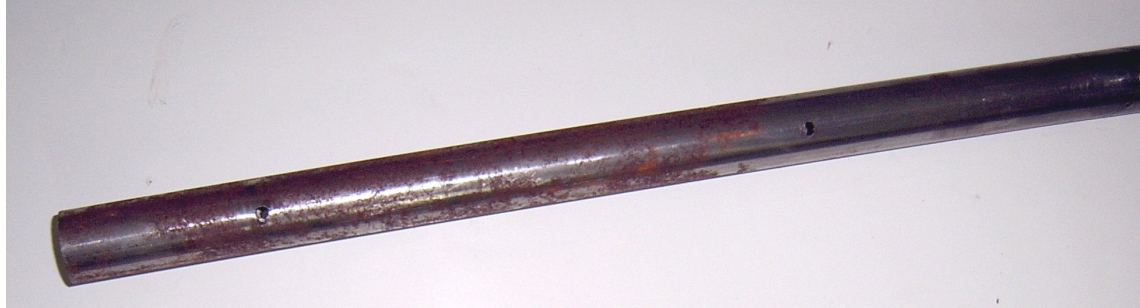
Rust on some areas of the bars. Some bars have traces of adhesive tape attached.

Rust on the end of the bar.

The bars were cleaned mechanically and the traces of adhesive tape were removed by means of an aromatic solvent. Finally varnish was applied to the cleaned areas to achieve an even gloss.

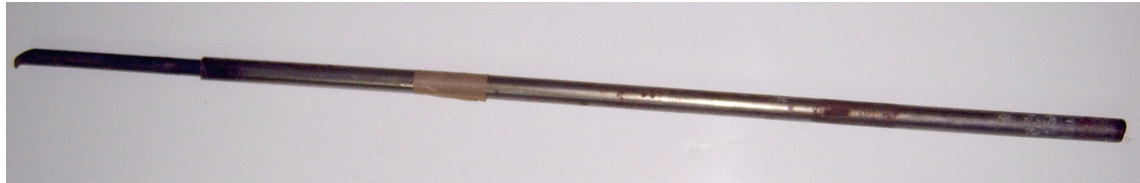
Rust and traces of adhesive tape.

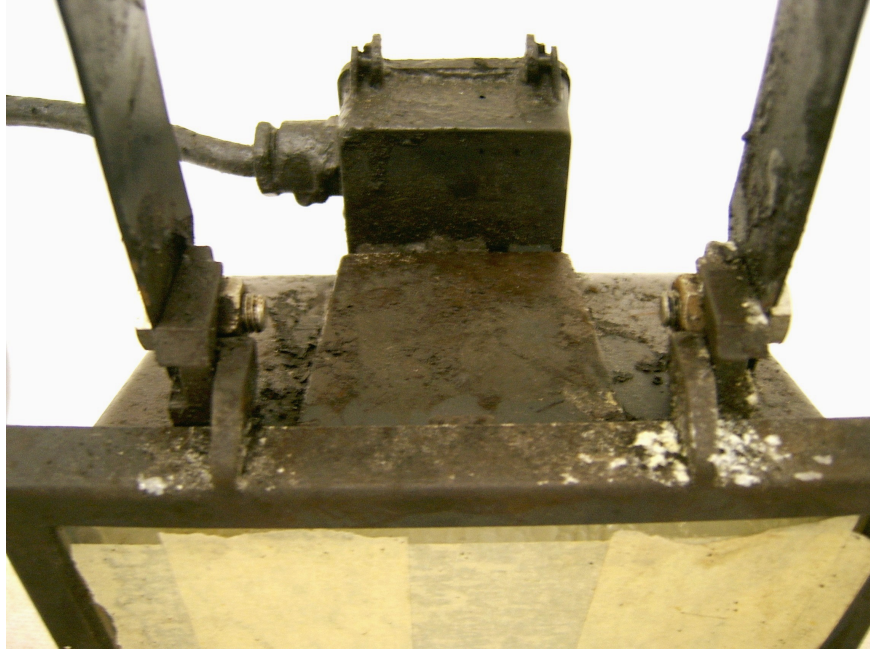
Loss of paint and rust on the halogen lamp, and traces of copper sulphate on the glass. The cable has lost its coating and has no plug.

Loss of paint and rust on the halogen lamp.

The cable of the halogen lamp is replaced. Finally, the artist decides to replace the 300-watt lamp with a 500-watt lamp because he thought the old one did not illuminate the work adequately.

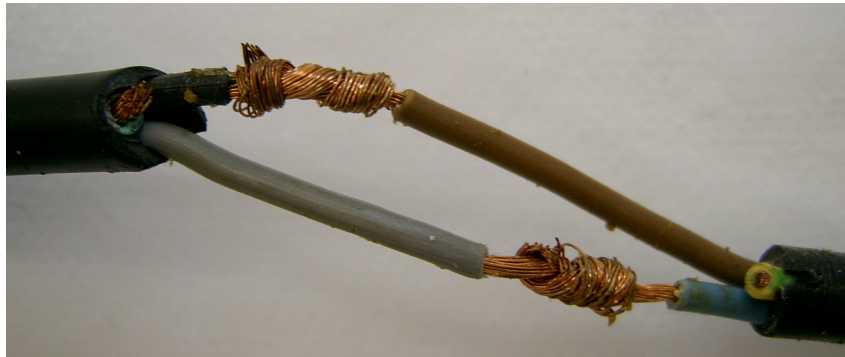
Initial state of the halogen lamp cable.

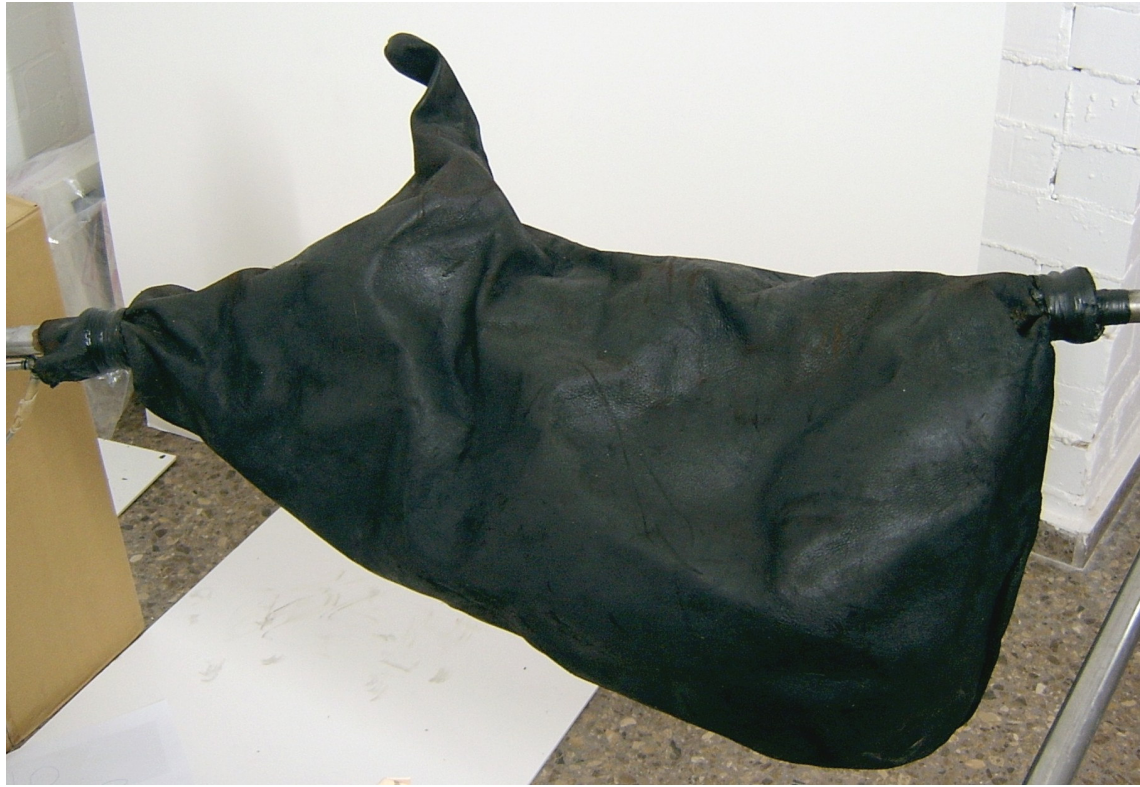
The wineskin is scratched and slightly soiled. Slight superficial dirt is adhered to it and the black coating is missing from some areas. However, it is free from fungus and breakages.

Location of scratches.

The artist applies 3-in-1 oil on the wineskin to increase elasticity.

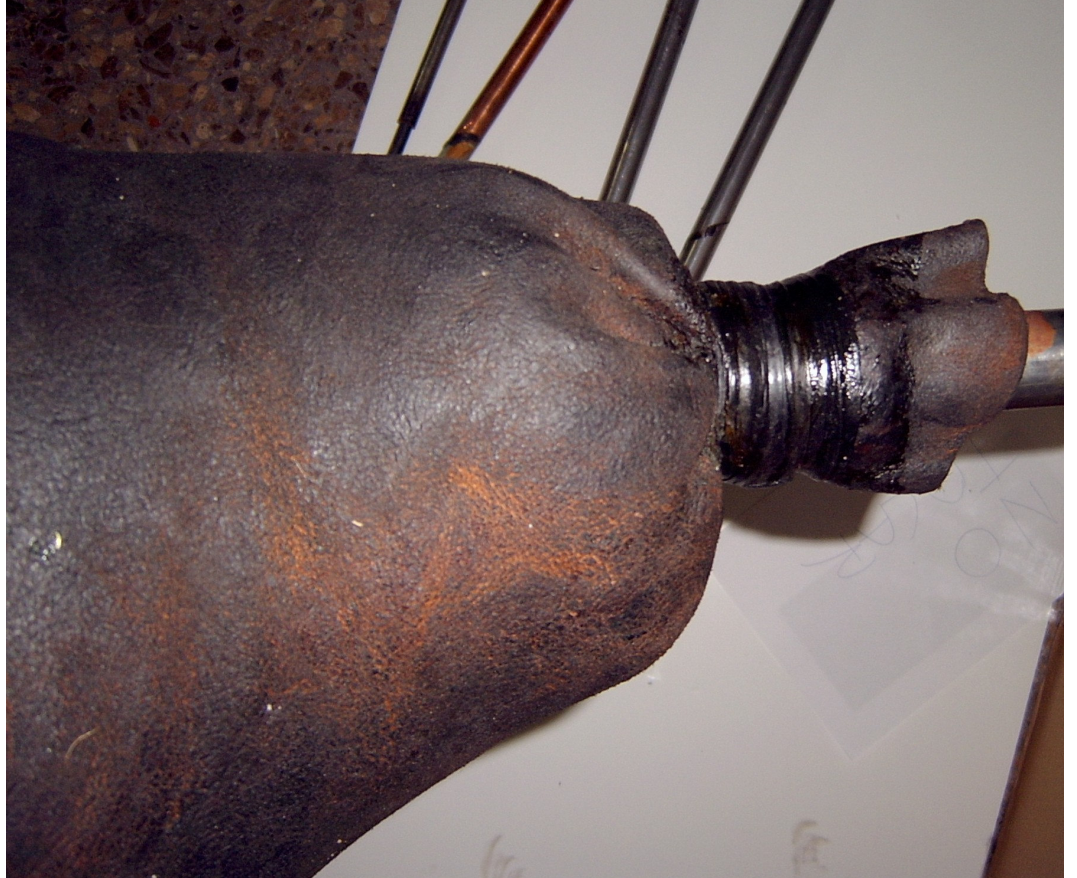
Places where the black coating was not applied.

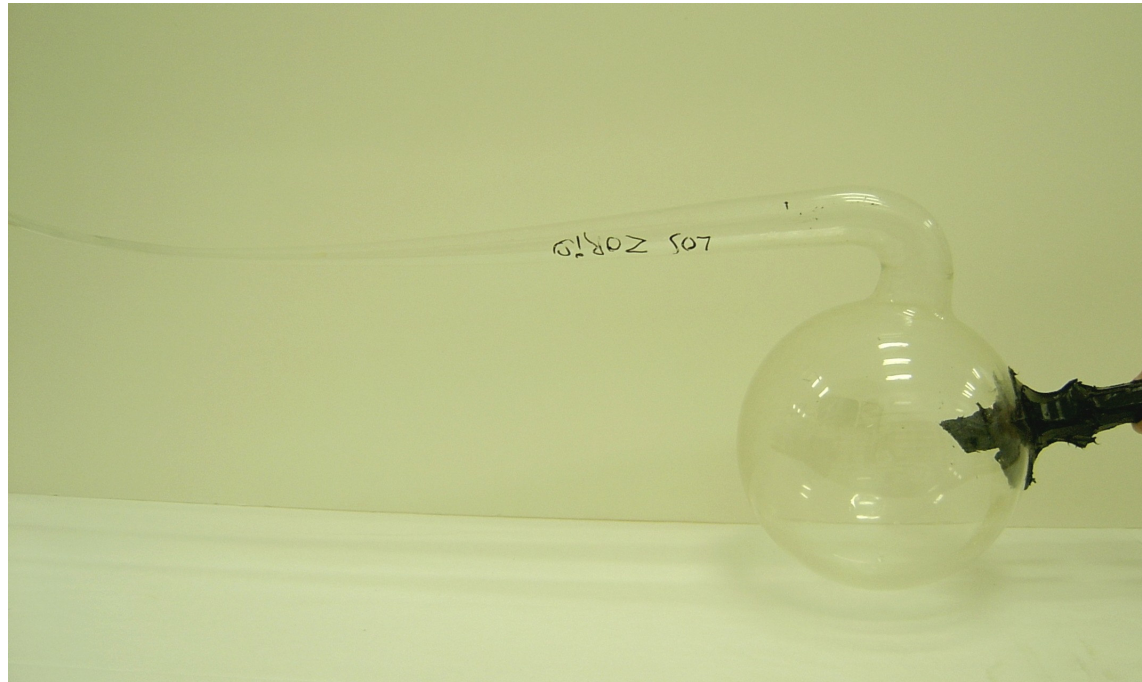
Final state of the crucible. The title of the piece written in black was later removed when the piece was assembled in accordance with the artist's wishes.
