**title: Conservation treatment report
of the 1977 image**

case: Joseph Kosuth, *Glass (one and three)*, 1965

date: January 12, 2006

Condition treatment report

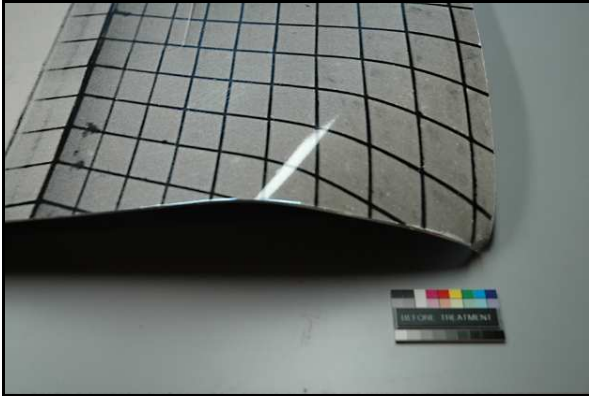
The lower left corner is badly bowed due to a fall that the image had. The emulsion in the left lower corner is damaged due to the fall and in the baryta layer is visible in many areas. Due to the damage in these areas the baryta layer has become powdery.

Before treatment: detail showing the damage to the lower left corner

2. The warped left lower corner of the aluminium panel was flattened using mechanical manipulation. The small corner which was turned inward was firstly flattened using blotting paper, wood and a vice. The corner was sandwiched between layers of blotting paper and wood and the vice was slowly fastened to produce mechanical force and flatten the corner. Next the larger corner was sandwiched between blotting paper and wood laminates and hardboards of various thickness and hardness. These boards are used in object conservation to prevent marks from forming when using vices to hold together pieces of freshly adhered wood.

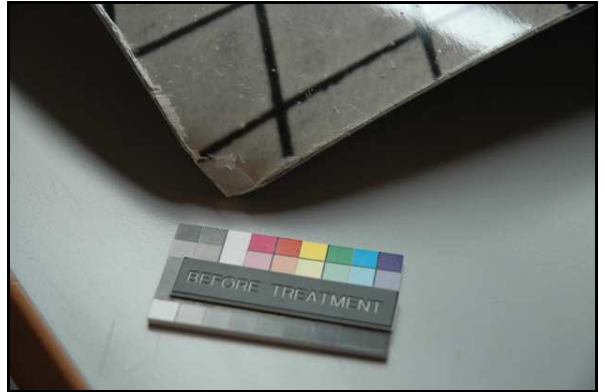
Before treatment: detail showing the lower left corner and the damage to the emulsion

4. Torn areas of the photograph along the lower left corner and along the right edge were consolidated using a 1.5% solution of photographic gelatine in deionised water.

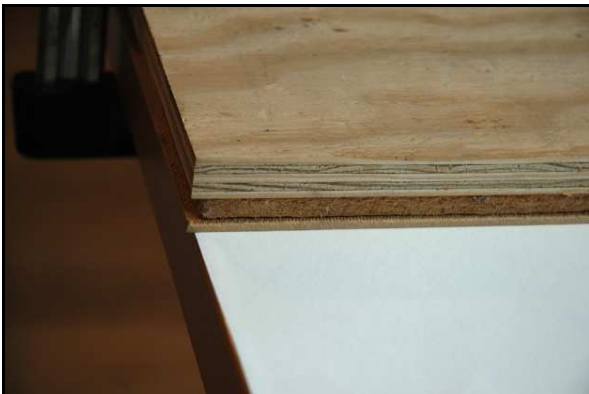
During treatment: the layers of blotting paper and boards used to flatten the corner

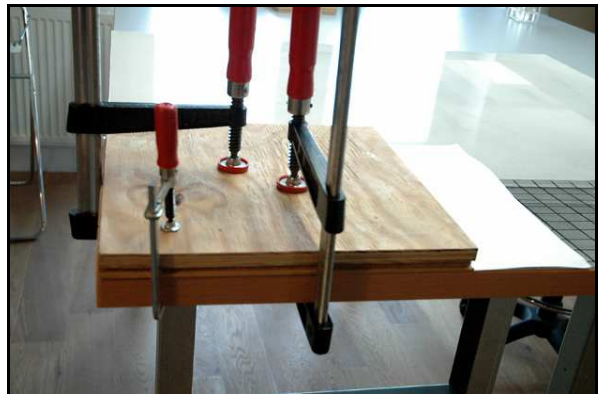
During treatment: the clamps and boards used to flatten the corner. The white showing from under the boards is blotting paper

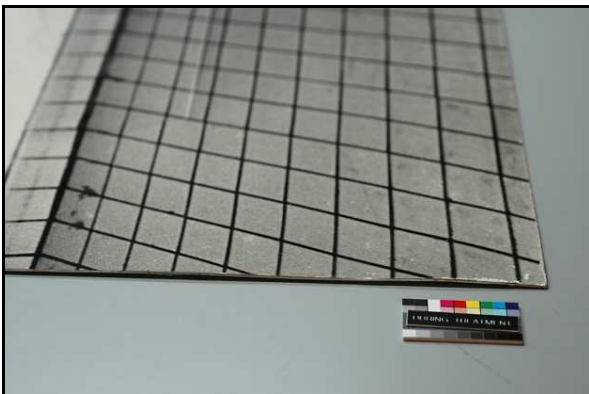
During treatment: detail showing the lower left corner after flattening

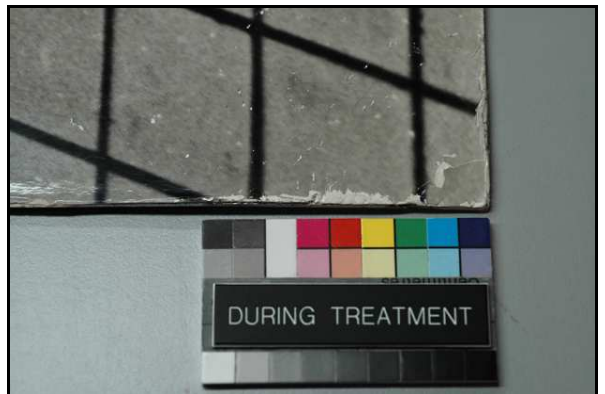
During treatment: detail of the lower left corner after flattening

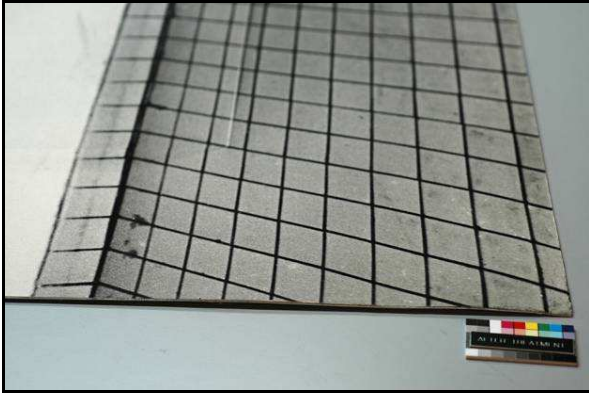
After treatment: detail showing the lower left corner after retouching

6. Damaged areas in the photograph emulsion were retouched using a soft graphite pencil and / or pigments (different mixtures of lamp, mars and spinel black) mixed with photographic gelatine to achieve a gloss corresponding to that of the photograph emulsion.

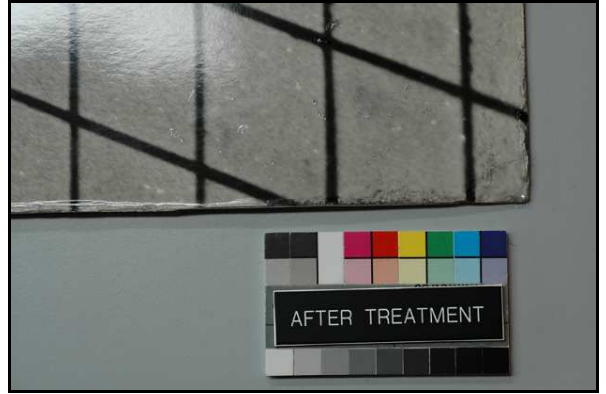
After treatment: detail showing the lower left corner after retouching

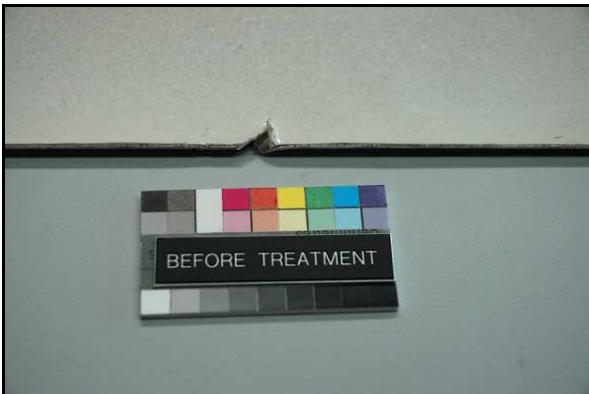
Two areas along the right edge of the image are also damaged. In the centre of the right edge, the aluminium is gauged. The emulsion and fibre-based paper are lifted from the aluminium panel and torn. Some lacunae's are visible in the paper. Twenty centimetres beneath this gauged area, the photograph paper is also detached and torn. The aluminium panel is not damaged in this area.

Before treatment: detail showing the gauge at the center of the right edge

3. The gauge in the right edge of the aluminium was consolidated using mechanical manipulation from the same vice and blotter sandwich that was used to flatten the small lower left corner. Putting pressure on the aluminium allowed the damaged area to become flattened and forced the split to narrow. Consolidation of the aluminium substrate was not necessary.

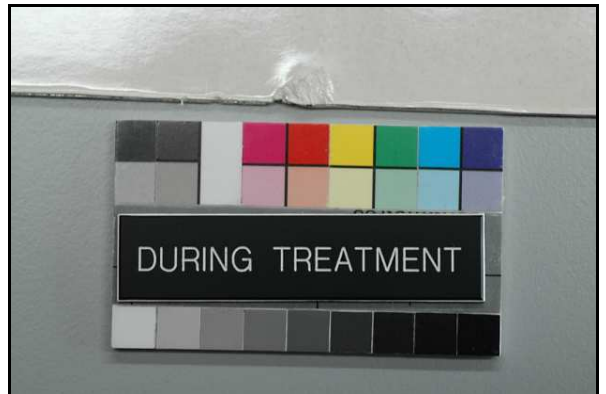
During treatment: detail showing gauge after flattening

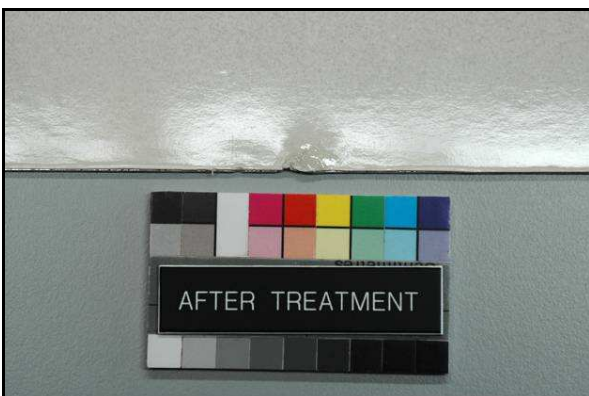
After treatment: detail showing gauge after gelatine consolidation

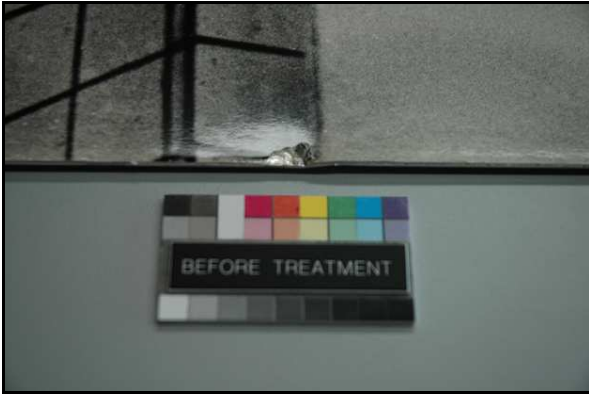
Before treatment: detail showing damaged paper at the lower right edge

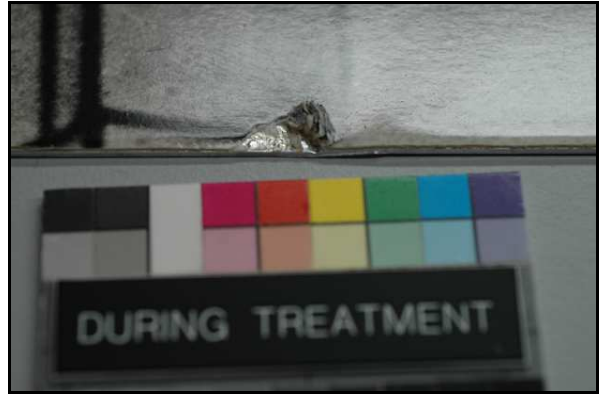
During treatment: detail showing damaged paper at the lower right edge

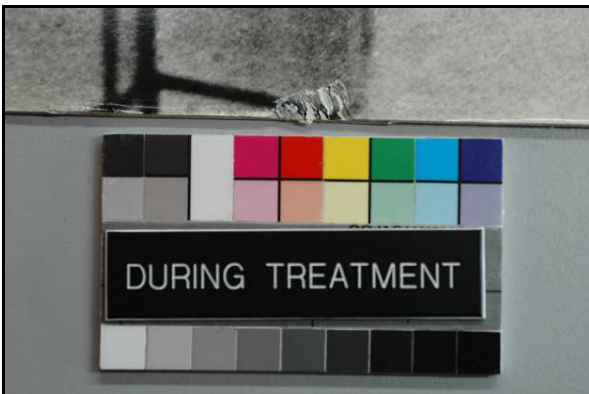
During treatment: detail showing emulsion after flattening

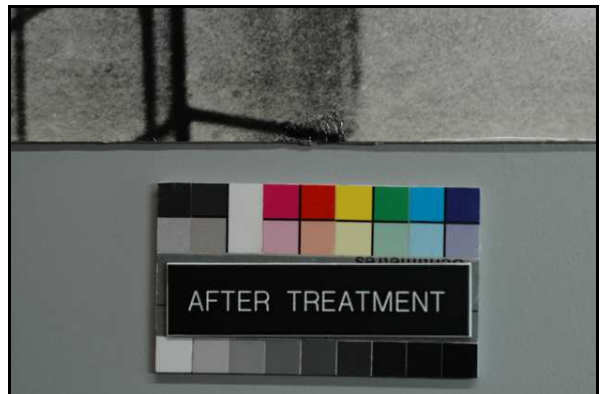
After treatment: detail showing fingerprints and surface grime reduced

7. Fingerprints, soil and grime on the surface of the emulsion were reduced with a cotton swab wetted with a 60% mixture of 99.5% pure ethanol mixed with deionised water.

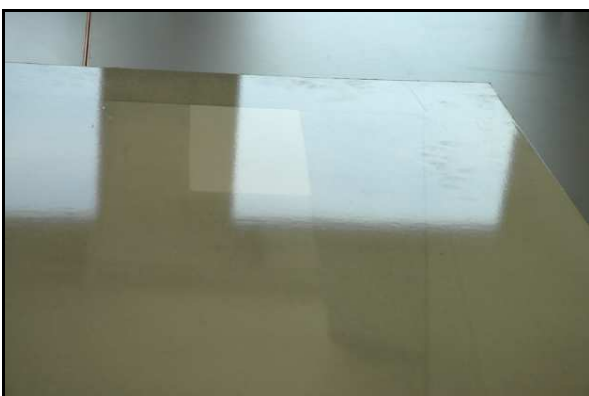
Three large scratches are visible in the dark image area of the tiled floor. Many fingerprints (ca. 23) and a few areas of surface grime are locally visible in particular along all edges of the image. The emulsion is damaged in at least 3 areas along the edges of the image. A lacunae in the emulsion (ca. 3 x 20 mm) is visible along the left upper edge.

Before treatment: detail showing fingerprints and surface grime

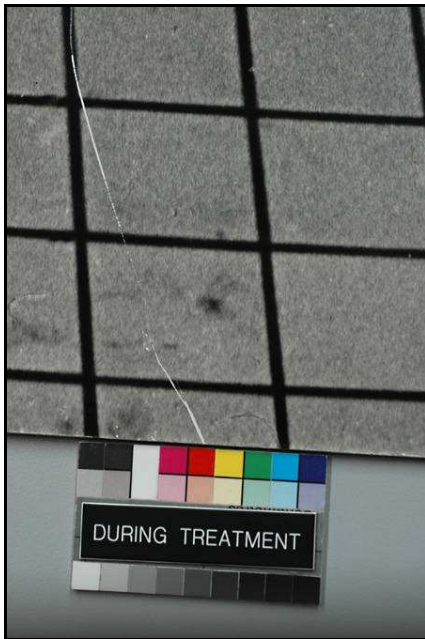
Before treatment: detail showing one of the scratches after consolidation and prior to retouching

5. The damaged areas of the photograph emulsion (scratches, tears and the damaged areas along the lower left corner and the right edge) were isolated using two applications of a 5% solution of photographic gelatine in deionised water. Photographic grade gelatine was used for its adhesive properties and because the gloss corresponds to that of the emulsion of the photograph. The isolation layer was allowed to dry for a week before further treatment was performed.

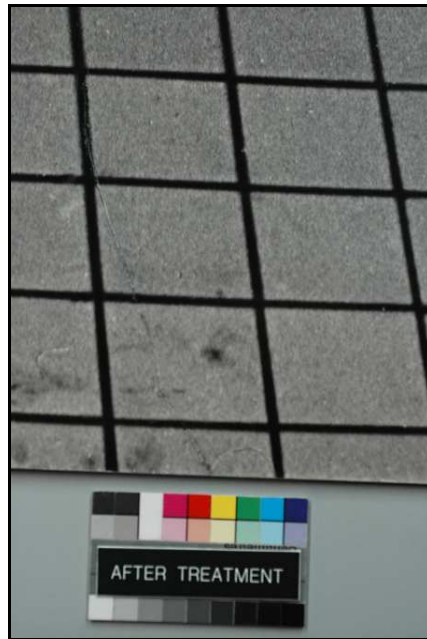
After treatment: detail showing the scratch after retouching using a mixture of black pigments in photographic gelatine
