Conservation Strategies

Authors: Thomas Zirlewagen, Fenna Yola Tykwer
Case Study: Fabrizio Plessi, *Liquid Time II* (1993)
Publisher: ZKM / Center for Art and Media Karlsruhe
Date: April 2007

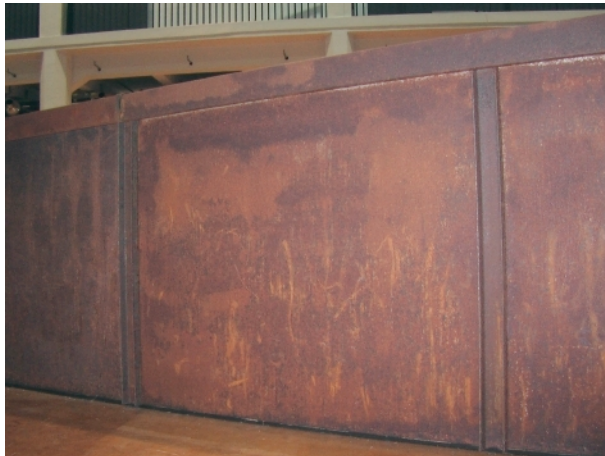
Mechanical actions grind the corrosion layer into fine rust dust, and bright red wipe traces emerge. The loss of rust particles in extremely corroded areas already poses a threat as in places these particles are only loosely connected to the surface. Along exposed edges the corrosion layer has rubbed off and the shine of the metal is exposed.

Fig. 1: Channel component III showing damage by abrasion of rust surface (bright red wipe traces) (March 2006) (photo: ZKM)

Lighter areas of abraded rust can be seen in fig. 1. The mainly vertical traces were caused by visitors, despite the advisory signs.

As a result, it is not permitted to touch the object in the exhibition, and advisory signs have to be put up for the visitors. The guards are to be instructed accordingly. It also means, however, that assembly and disassembly have to be done with extreme care. Latex gloves must be worn and all surfaces to be touched must be padded and covered with a smooth material.

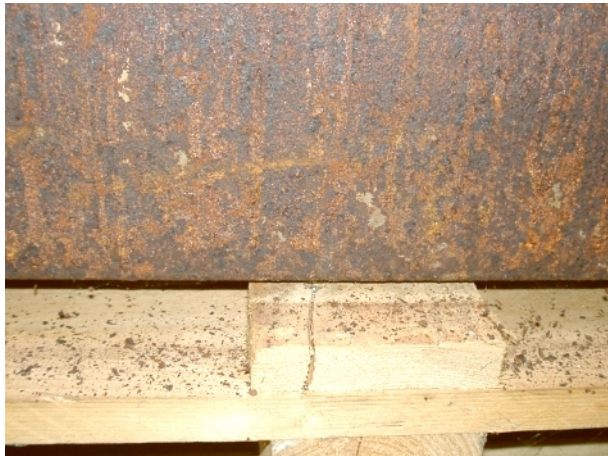
All visible surfaces of the steel construction were deliberately corroded with an acid solution when the work was made, resulting in a sensitive, predominantly matte rust surface whose coloration varies between bright rust red and brownish black. The consistency of the rust surfaces ranges from stable to fine powder and encrusted areas with pronounced, small, loose lamellae.

Fig. 2: Detail of the channel's outside with lightly adhering encrusted areas and loose rust particles (September 2004) (photo: ZKM)

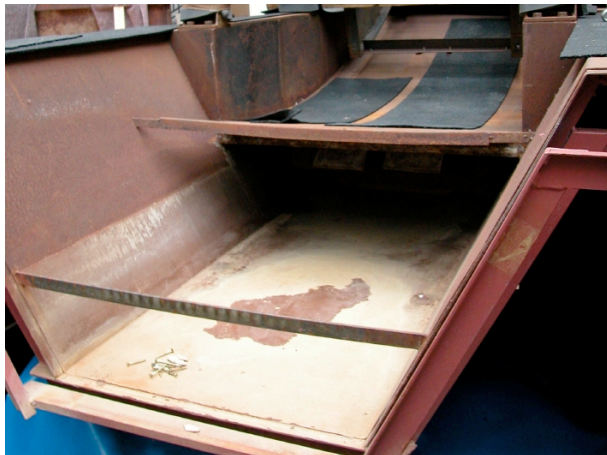
Evaporation also causes the mineral salts contained in water - primarily calcium carbonate- to accumulate. They collect in the water channel as a mineral layer. Fig. 3 from August 2004 shows calcium carbonate deposits still remaining from the first three presentations. They adhere on the brown protective coating of the water channel, which is normally covered by grilles. An attempt was made during the 2004 installation to chip the calcium encrustation off mechanically. This was, however, successful only in a few small areas. The idea of removing calcium deposits with acid was rejected out of concern for the protective coating.

Fig. 3: Detail of water channel component V showing old calcium carbonate deposits from 1993 (August 2004) (photo: ZKM)

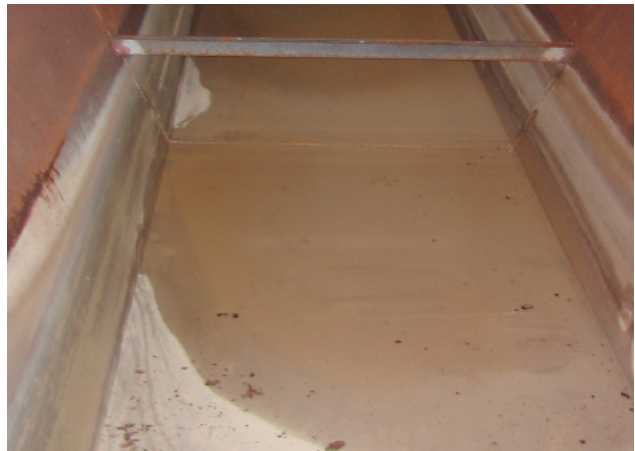
Fig. 4: Detail of the water channel with a strong layer of calcium carbonate after two years presentation (October 2006) (photo: ZKM)

The drinking water in Karlsruhe has a degree of hardness of 18° dH ("deutscher Härte" or German degree of hardness). This corresponds to a content of 180 mg of CaO ions per one litre of water. In order to minimize the salt content of the water from the outset, partially demineralized water with a hardness of 5° dH has been used since 2004; it is processed at the ZKM in larger quantities for use in the air conditioning system and kitchen operations.

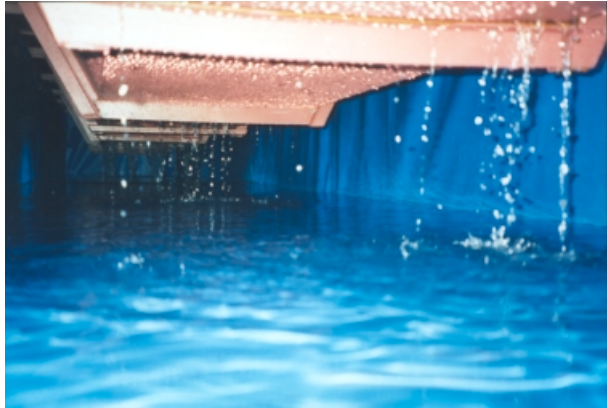
In places rust areas emerge at the struts that carry the tank elements. Water runs over these during operation, and their protective coating shows minor damage that becomes rusty. This damage should be repaired before the next reinstallation of the work.

Fig. 5: Space underneath the tank panels: during operation water runs through the joints between the tank panels (photo: ZKM)

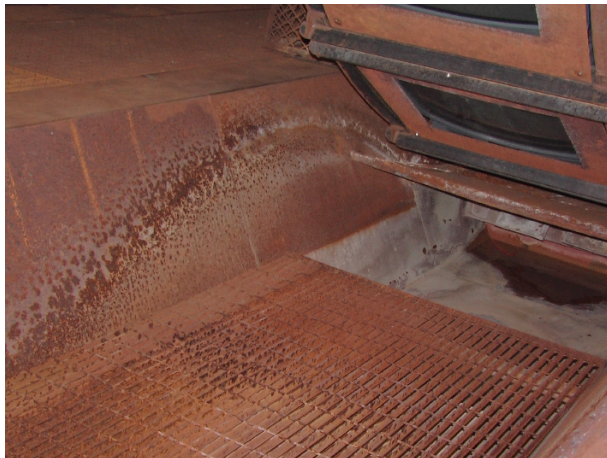
One special problem zone is the channel area beneath the wheel. Here the water bubbles into the channel and splash water on both sides regularly wets the unprotected tank panels above the grille. If the system is switched off, these areas dry out again. This alternation led, over the long exhibition period, to a considerable progressing of corrosion in the splash water area. One arched zone is particularly affected; this area is also exposed during operation to a constant short-term alteration of wetting and drying (see figs. 6 - 9). The area beneath the arch, which is constantly wet during operation and dries only once a day, is noticeably less corroded. As the illustrations show, the development of the corrosion is alarming. In order to be able to find approaches for the handling of the corrosion, external specialists as well as metal conservators must be consulted.

Fig. 6: Channel component V, splash water area beneath the wheel after ten months of presentation: compared to fig. 3 the development of corrosion become apparent (August 2005) (photo: ZKM)

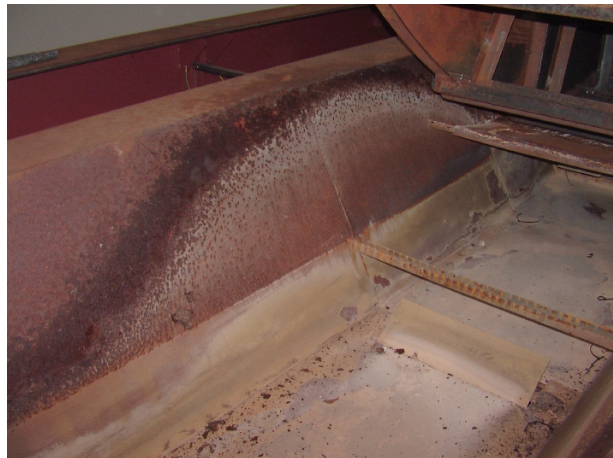
Fig. 7: as fig. 6 after 24 months of presentation: considerable augmentation of corrosion. (October 2006) (photo: ZKM)

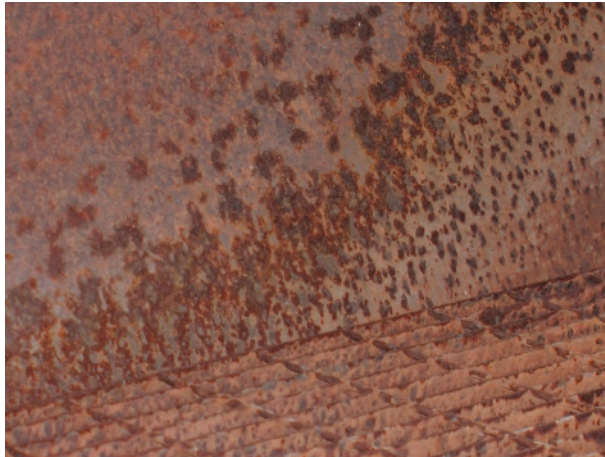
Fig. 8: Detail from fig. 6 (August 2005) (photo: ZKM)

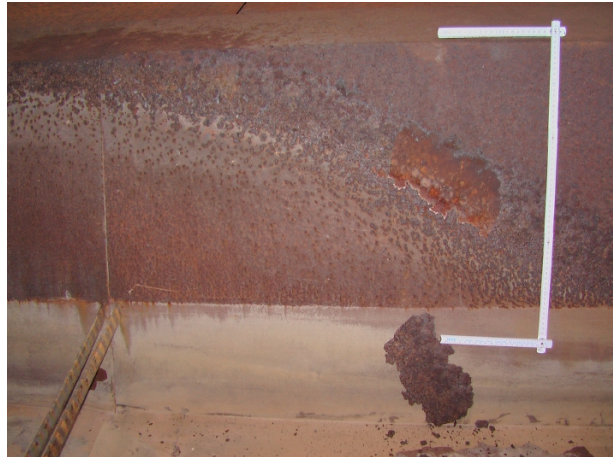
Fig. 9: Detail of splash water area, right side of water tank: Partial loss of corrosion layer (March 2006) (photo: ZKM)

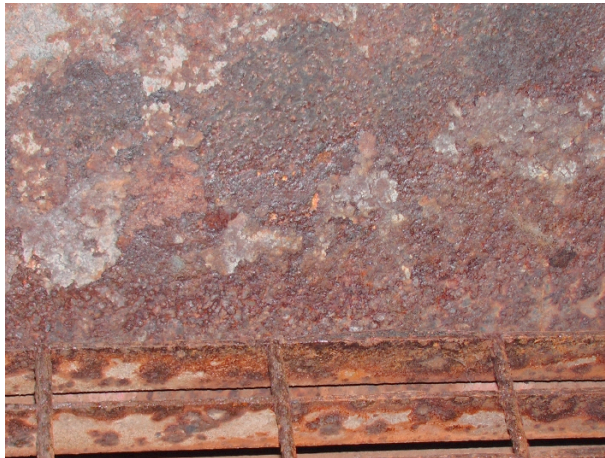
Fig. 10: Detail of grille and tank panel (March 2006) (photo: ZKM)

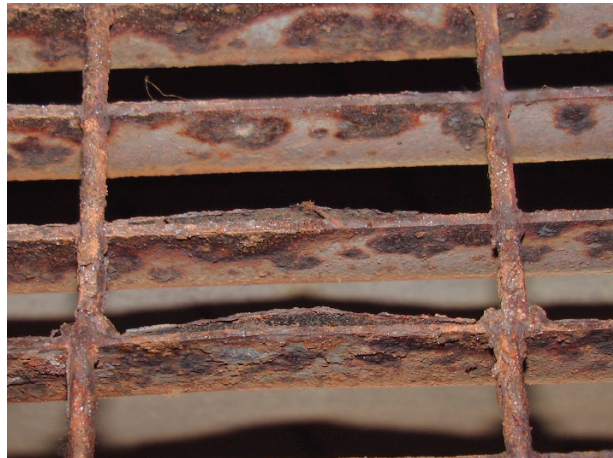
Fig. 11: Detail of the grille: detached corrosion layers (March 2006) (photo: ZKM)

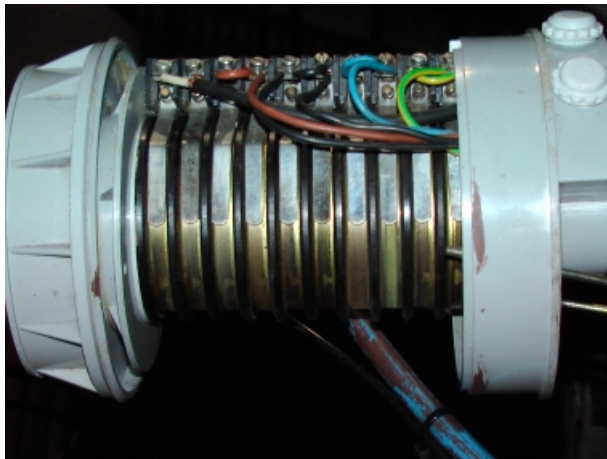
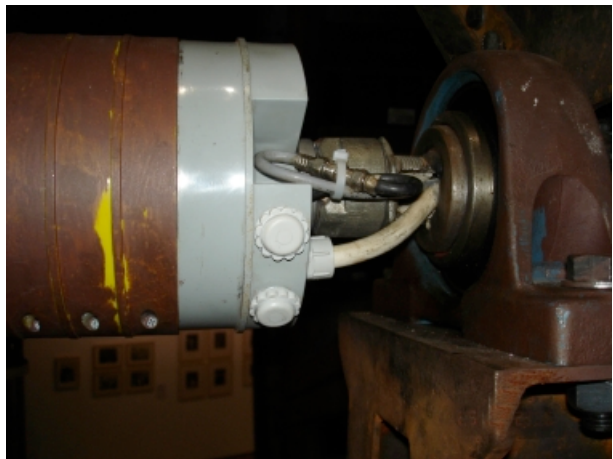
Fig. 12: Original slip ring unit without cover: The photo shows the ten slip rings and contacts inside the unit (August 2004) (photo: ZKM)

Fig. 13: Original slip ring unit and its connection to the wheel axle (August 2004) (photo: ZKM)

The slip ring unit functioned reliably during the first six months. Afterward wear and tear on the contacts (hard nonferrous metal alloy) and contaminations through abrasion led more and more frequently to interruptions in the transmission. The video signal was particularly affected.

Nevertheless more and more problems occur due to breaks and peaks of power supply also caused by unstable transmission via the slip rings. Finally the contacts were so worn-out that there was a very real fear that they would break off.

In July 2006 the decision was taken to replace the original slip ring unit by a new one. Contemporary technique has developed much smaller units with much higher security. The new slip rings are polished and special hard gold plated. This combination of gold to gold provides resistance to corrosion and ensures the highest quality of contact.

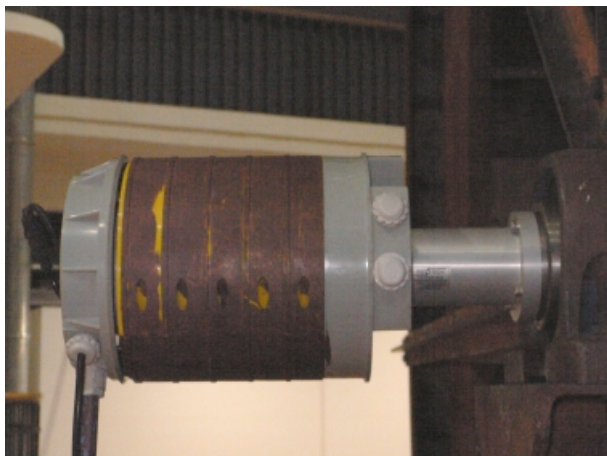
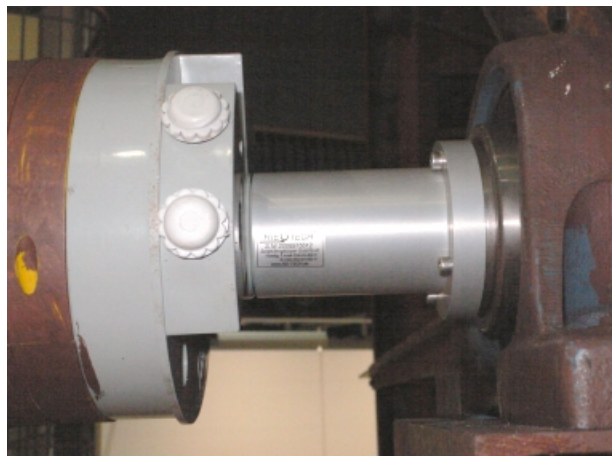
Fig. 14: New slip ring unit is hidden in the original housing. (October 2006) (photo: ZKM)

Fig. 15: The new connecting tube houses the cables. (October 2006) (photo: ZKM)

A new slip ring was conceived in collaboration with a specialist company. In this way a solution was sought that changes the original appearance as little as possible. The new slip ring body was successfully integrated into the housing of the original so that the external changes were minimal. The cables are hidden in the new connecting tube (see figs. 14 and 15).

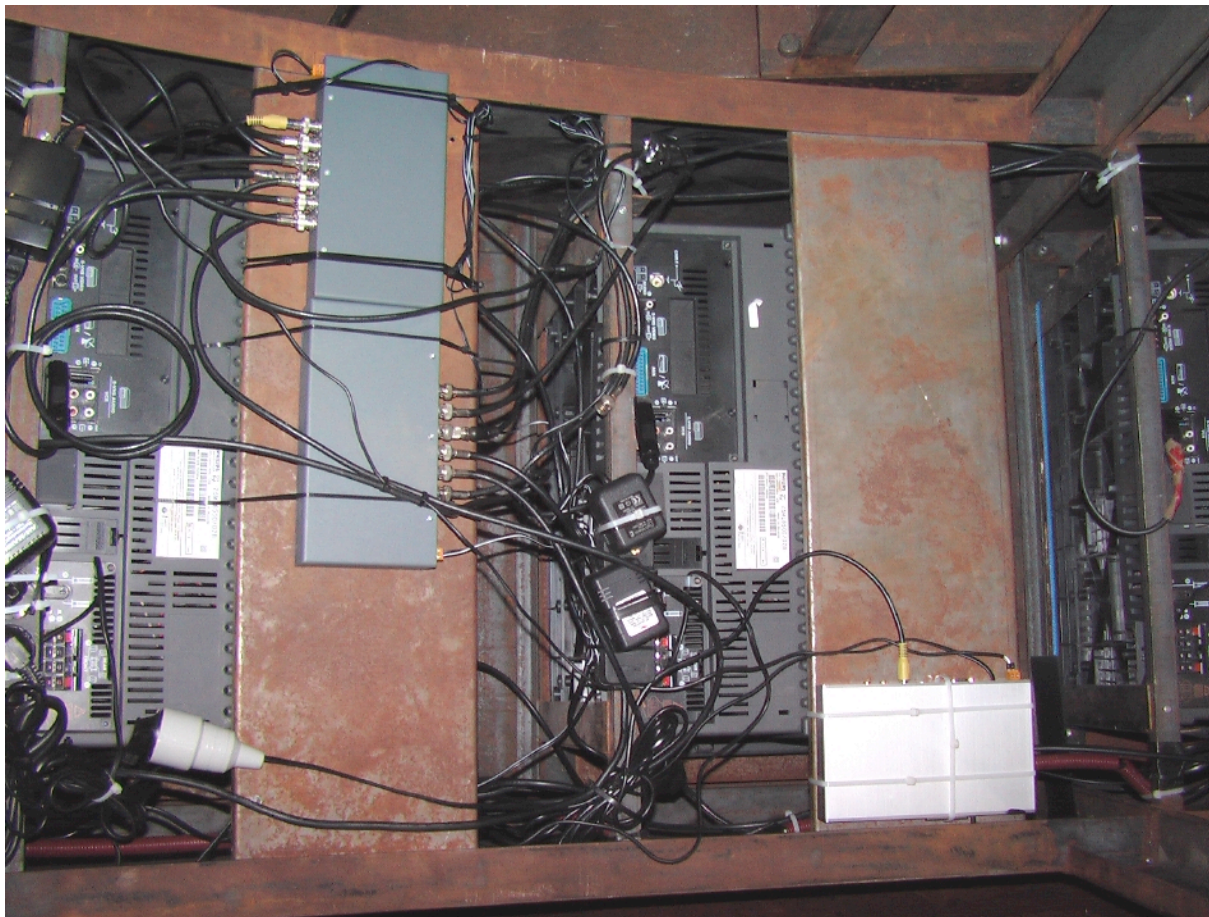
In May 2005 we started testing this solution, which turned out to be very promising. The video signal is stable and the televisions show a clear image. Interferences of the image have become noticeably fewer than before. The remaining faults were caused by unstable wiring and loose connections.

Fig. 16: View of one of the wheel segments where the new flash card player (silver) and two of the new video distributors (grey) are fixed during testing phase. (May 2005) (photo: ZKM)
