Restoration History

Authors: Thomas Zirlewagen, Fenna Yola Tykwer
Case Study: Fabrizio Plessi, *Liquid Time II* (1993)
Publisher: ZKM / Center for Art and Media Karlsruhe
Date: April 2007

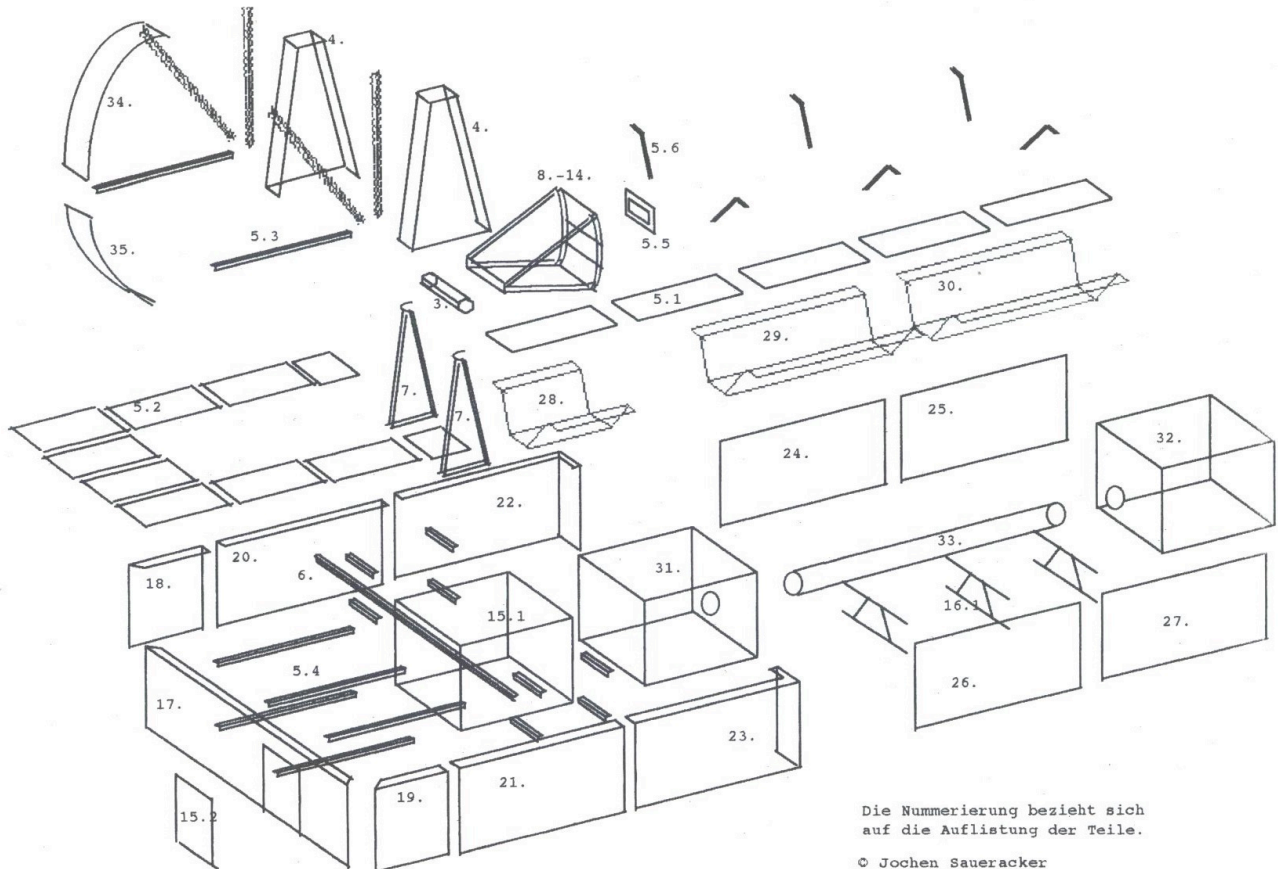
The components of the original steel construction were depicted in a list and a location drawing detailing all parts by Jochen Saueracker in 1997 (see fig. 1).

Fig. 1: Location drawing of the steel construction (illustration: Jochen Saueracker)

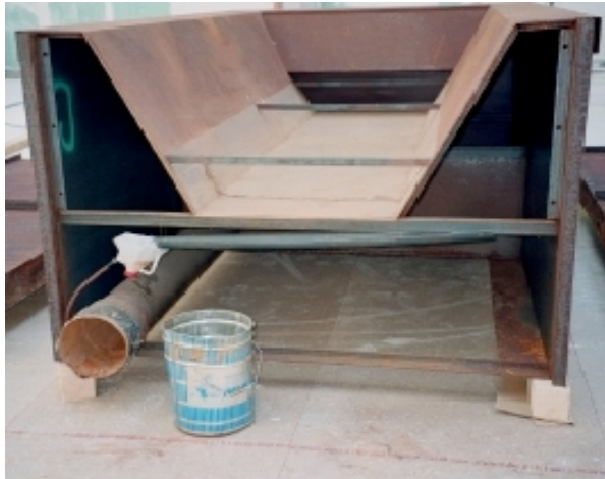
Channel component I (no 32) was one unit with a ca. 1 m long collecting basin underneath the tank panel over its whole breadth (see fig. 2).

Fig. 2: View into channel component I with one part of the reflux tube (1993) (photo: Jochen Saueracker)

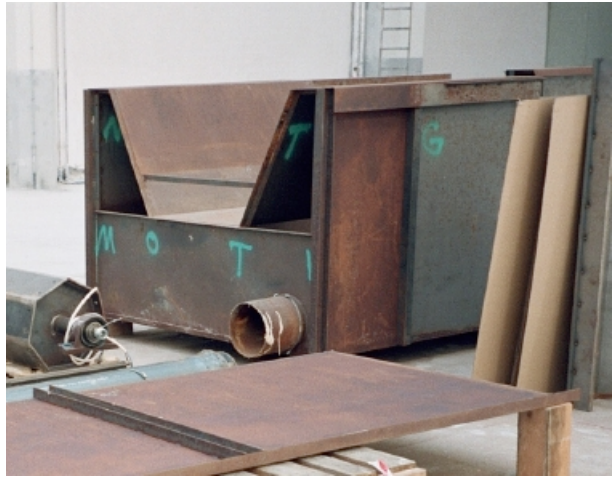
Likewise channel component IV was one unit (no 31, see fig. 3) with a continuous floor and a partition wall to component III, only half of the tank panel (no 28, to channel component V) was removable. Together with channel component V (no 15.1), IV formed a second collecting basin under the tank panels into which the pump's intake socket protruded.

Fig. 3: Channel component IV: Under the tank panel one can see the partition wall of the second basin and the entrance of the reflux tube (1993) (photo: Jochen Saueracker)

Until now, the lower part of the water circulation (reflux channel) was only accessible when at least one of the elements of the tank panels was taken out. Thus in 1997, it was decided to fit an inspection opening between the machine room and the reflux channel under the tank panels: A part of the side wall of channel component IV was removed for the inspection opening.

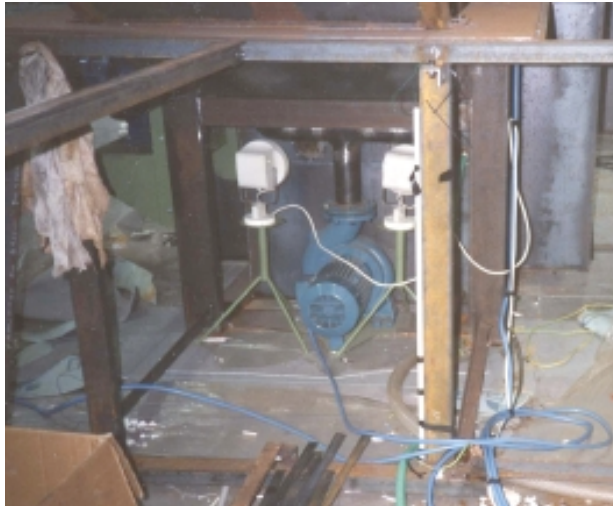
The original lighting of the water channel consisted of two spotlights on metal tripods standing on the left and right side of the pump. The spotlights shone into the channel through two small holes covered with glass (portholes) at the end of the channel under the wheel (see figs. 4 and 5).

Fig. 4: View of the original lighting: white spotlights with green painted tripods (1993) (photo: Jochen Saueracker)

- Dismantling original spotlights on green metal tripods behind the rear wall of the tank left and right of the pump and the protective glass / portholes (see fig. 4).
- Sealing of the openings in the in the basic construction using welded 4-mm-thick plates
- Attachment of two small halogen spotlights with one panel shade apiece over the water outlets

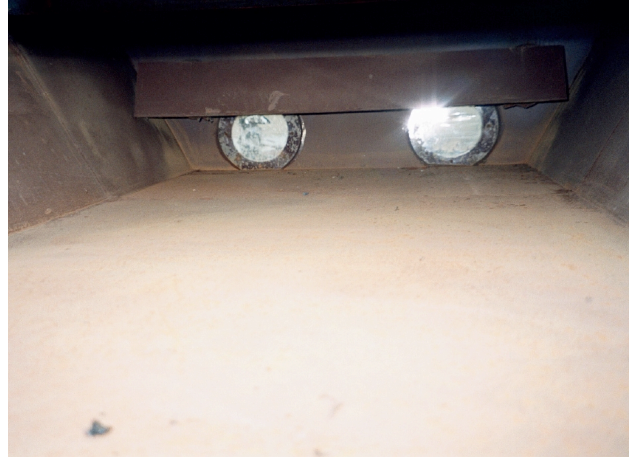
Fig. 5: Portholes at the end of the water channel (1993) (photo: Jochen Saueracker)

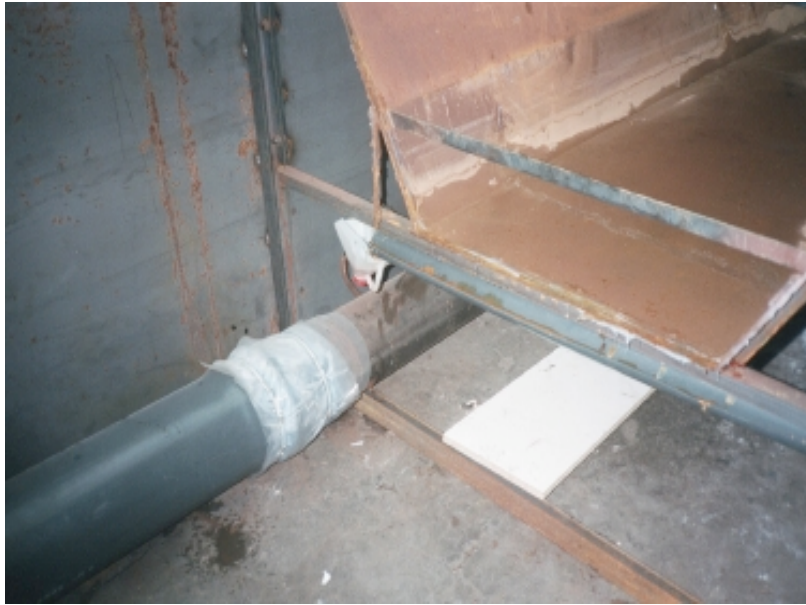
All the joints in the water circulation were sealed with silicon after assembling the steel construction, both the joints between the basin and the reflux pipe as well as the connections between the tank panels. These joints, however, soon became leaky and so dripping water reached the underbody around channel components I, II and III. Provisional gutters made of plastic had to be placed under the connections and a small hose to the basin in order to secure these problem areas (see figs. 6 and 7).

The tank circulation proved to be leaky so provisional gutters under the intersections of the individual tank panels had to be installed which were connected to the first collecting basin via a hose system (see figs. 6 and 7).

Fig. 6: Detail of channel components I und II (left site): Provisional sealing of the tube and gutter for dripping water (1993) (photo:: Jochen Saueracker)

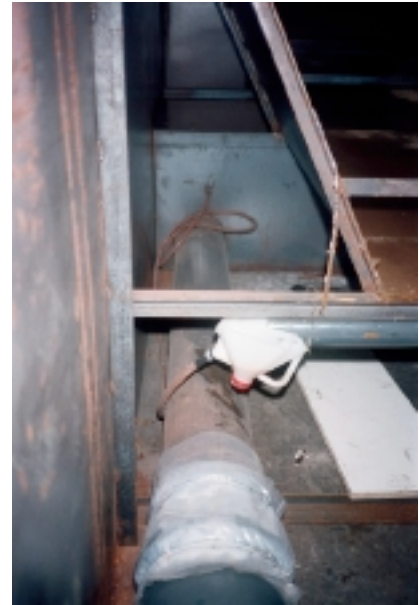
Fig. 7: The dripping water was led through a thin hose to the basin. (1993) (photo:: Jochen Saueracker)
