**title: Conservation treatment report
of the 1977 image**

case: Joseph Kosuth, *Glass (one and three)*, 1965

date: January 12, 2006

Condition treatment report

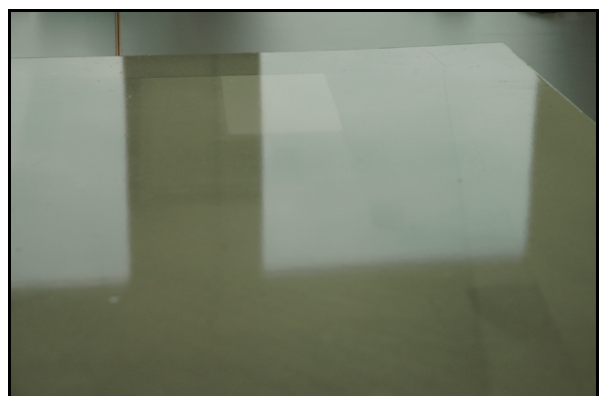
Three large scratches are visible in the dark image area of the tiled floor. Many fingerprints (ca. 23) and a few areas of surface grime are locally visible in particular along all edges of the image. The emulsion is damaged in at least 3 areas along the edges of the image. A lacunae in the emulsion (ca. 3 x 20 mm) is visible along the left upper edge.

Before treatment: detail showing fingerprints and surface grime

6. Reduce fingerprints, soil and grime on the surface of the emulsion using a mixture of appropriate solvents. Retouch damaged areas in the photograph emulsion using a soft graphite pencil or pigments mixed with an appropriate binder as necessary.
